**SUMMARY REPORT
OF THE EXISTING
STRUCTURAL
CONDITION SURVEYS**

**Forest City Ratner Companies
One Metrotech Center North
11th Floor
Brooklyn, NY 11201**

**LZA TECHNOLOGY
641 Avenue of the Americas
New York, NY 10011
917-661-7800**

November 07, 2005

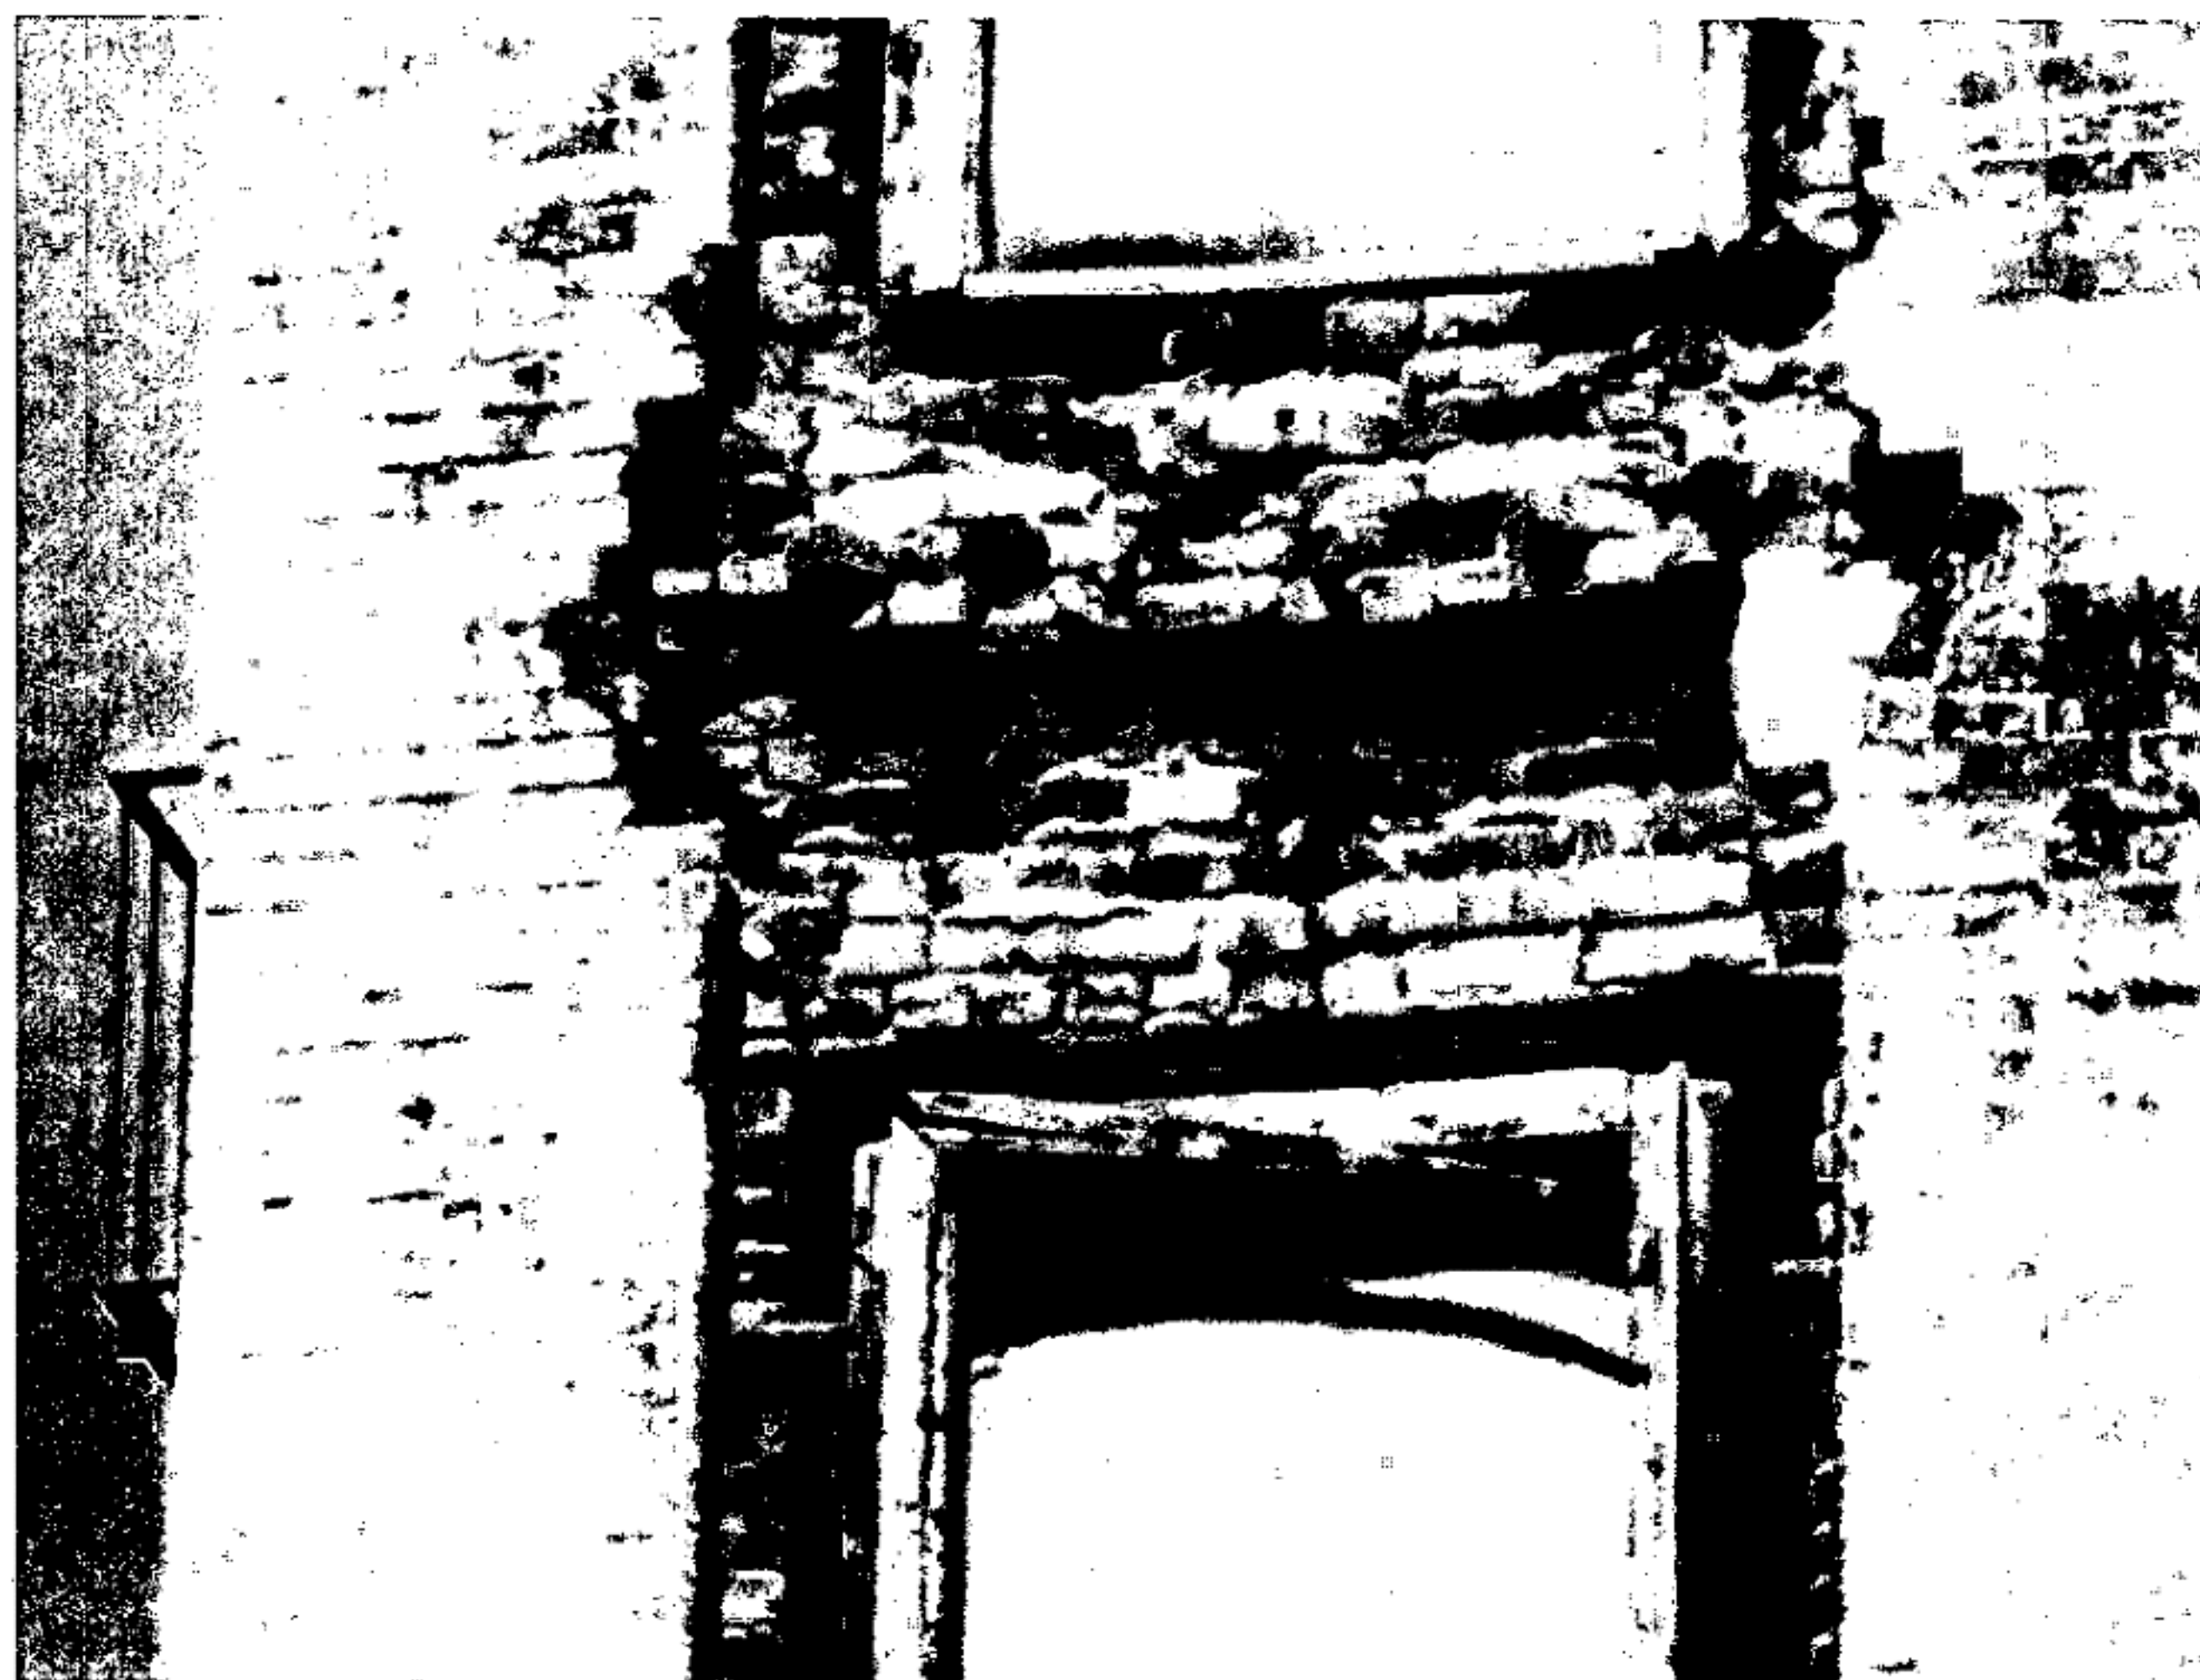
The condition of the southern portion of the East masonry wall of 620 Atlantic Avenue poses a possibility of falling bricks. Since this is a masonry-bearing wall, these conditions if left unchecked will eventually bring about local failure of the masonry-bearing wall and its timber floor system. This is further evidence that a major structural support system of the building is substantially compromised and that the structures are unsafe.

Photo No. 03 – Masonry East Bearing Wall Damage at 3rd & 4th Floors of 620 Atlantic Avenue

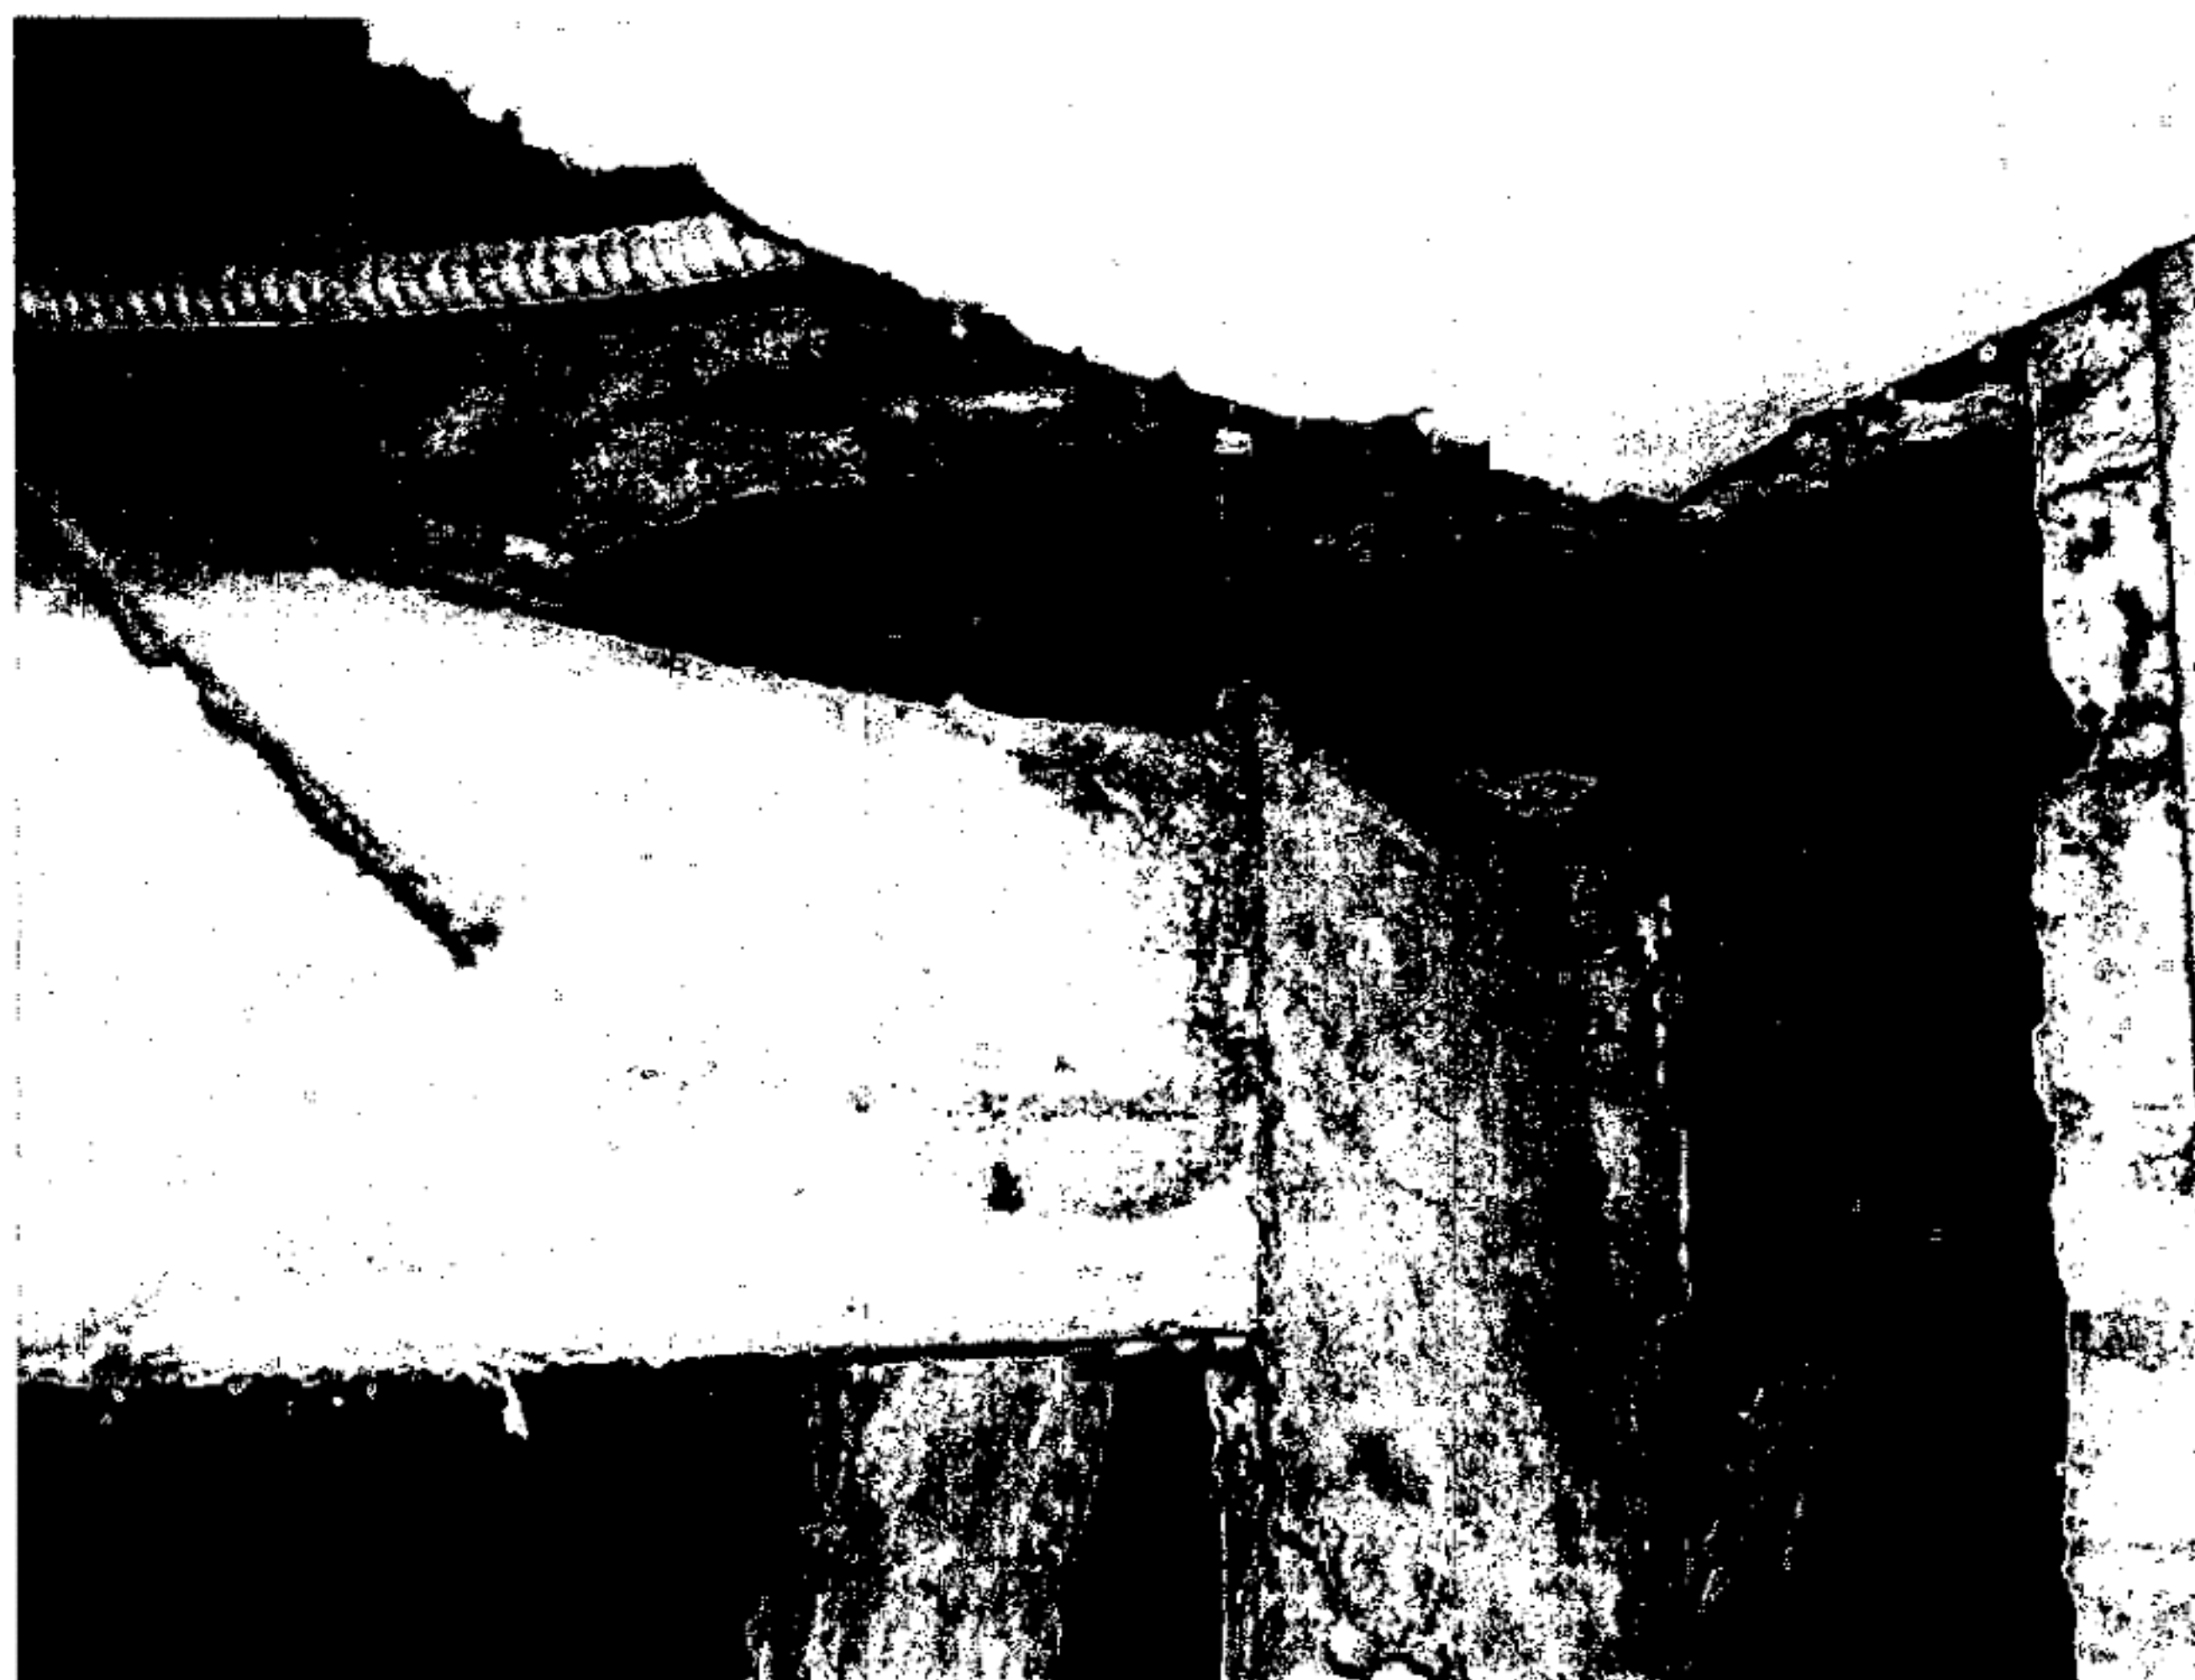
**Photo No. 06 – Timber Column and Girder Support Settlement of
618 Atlantic Avenue**

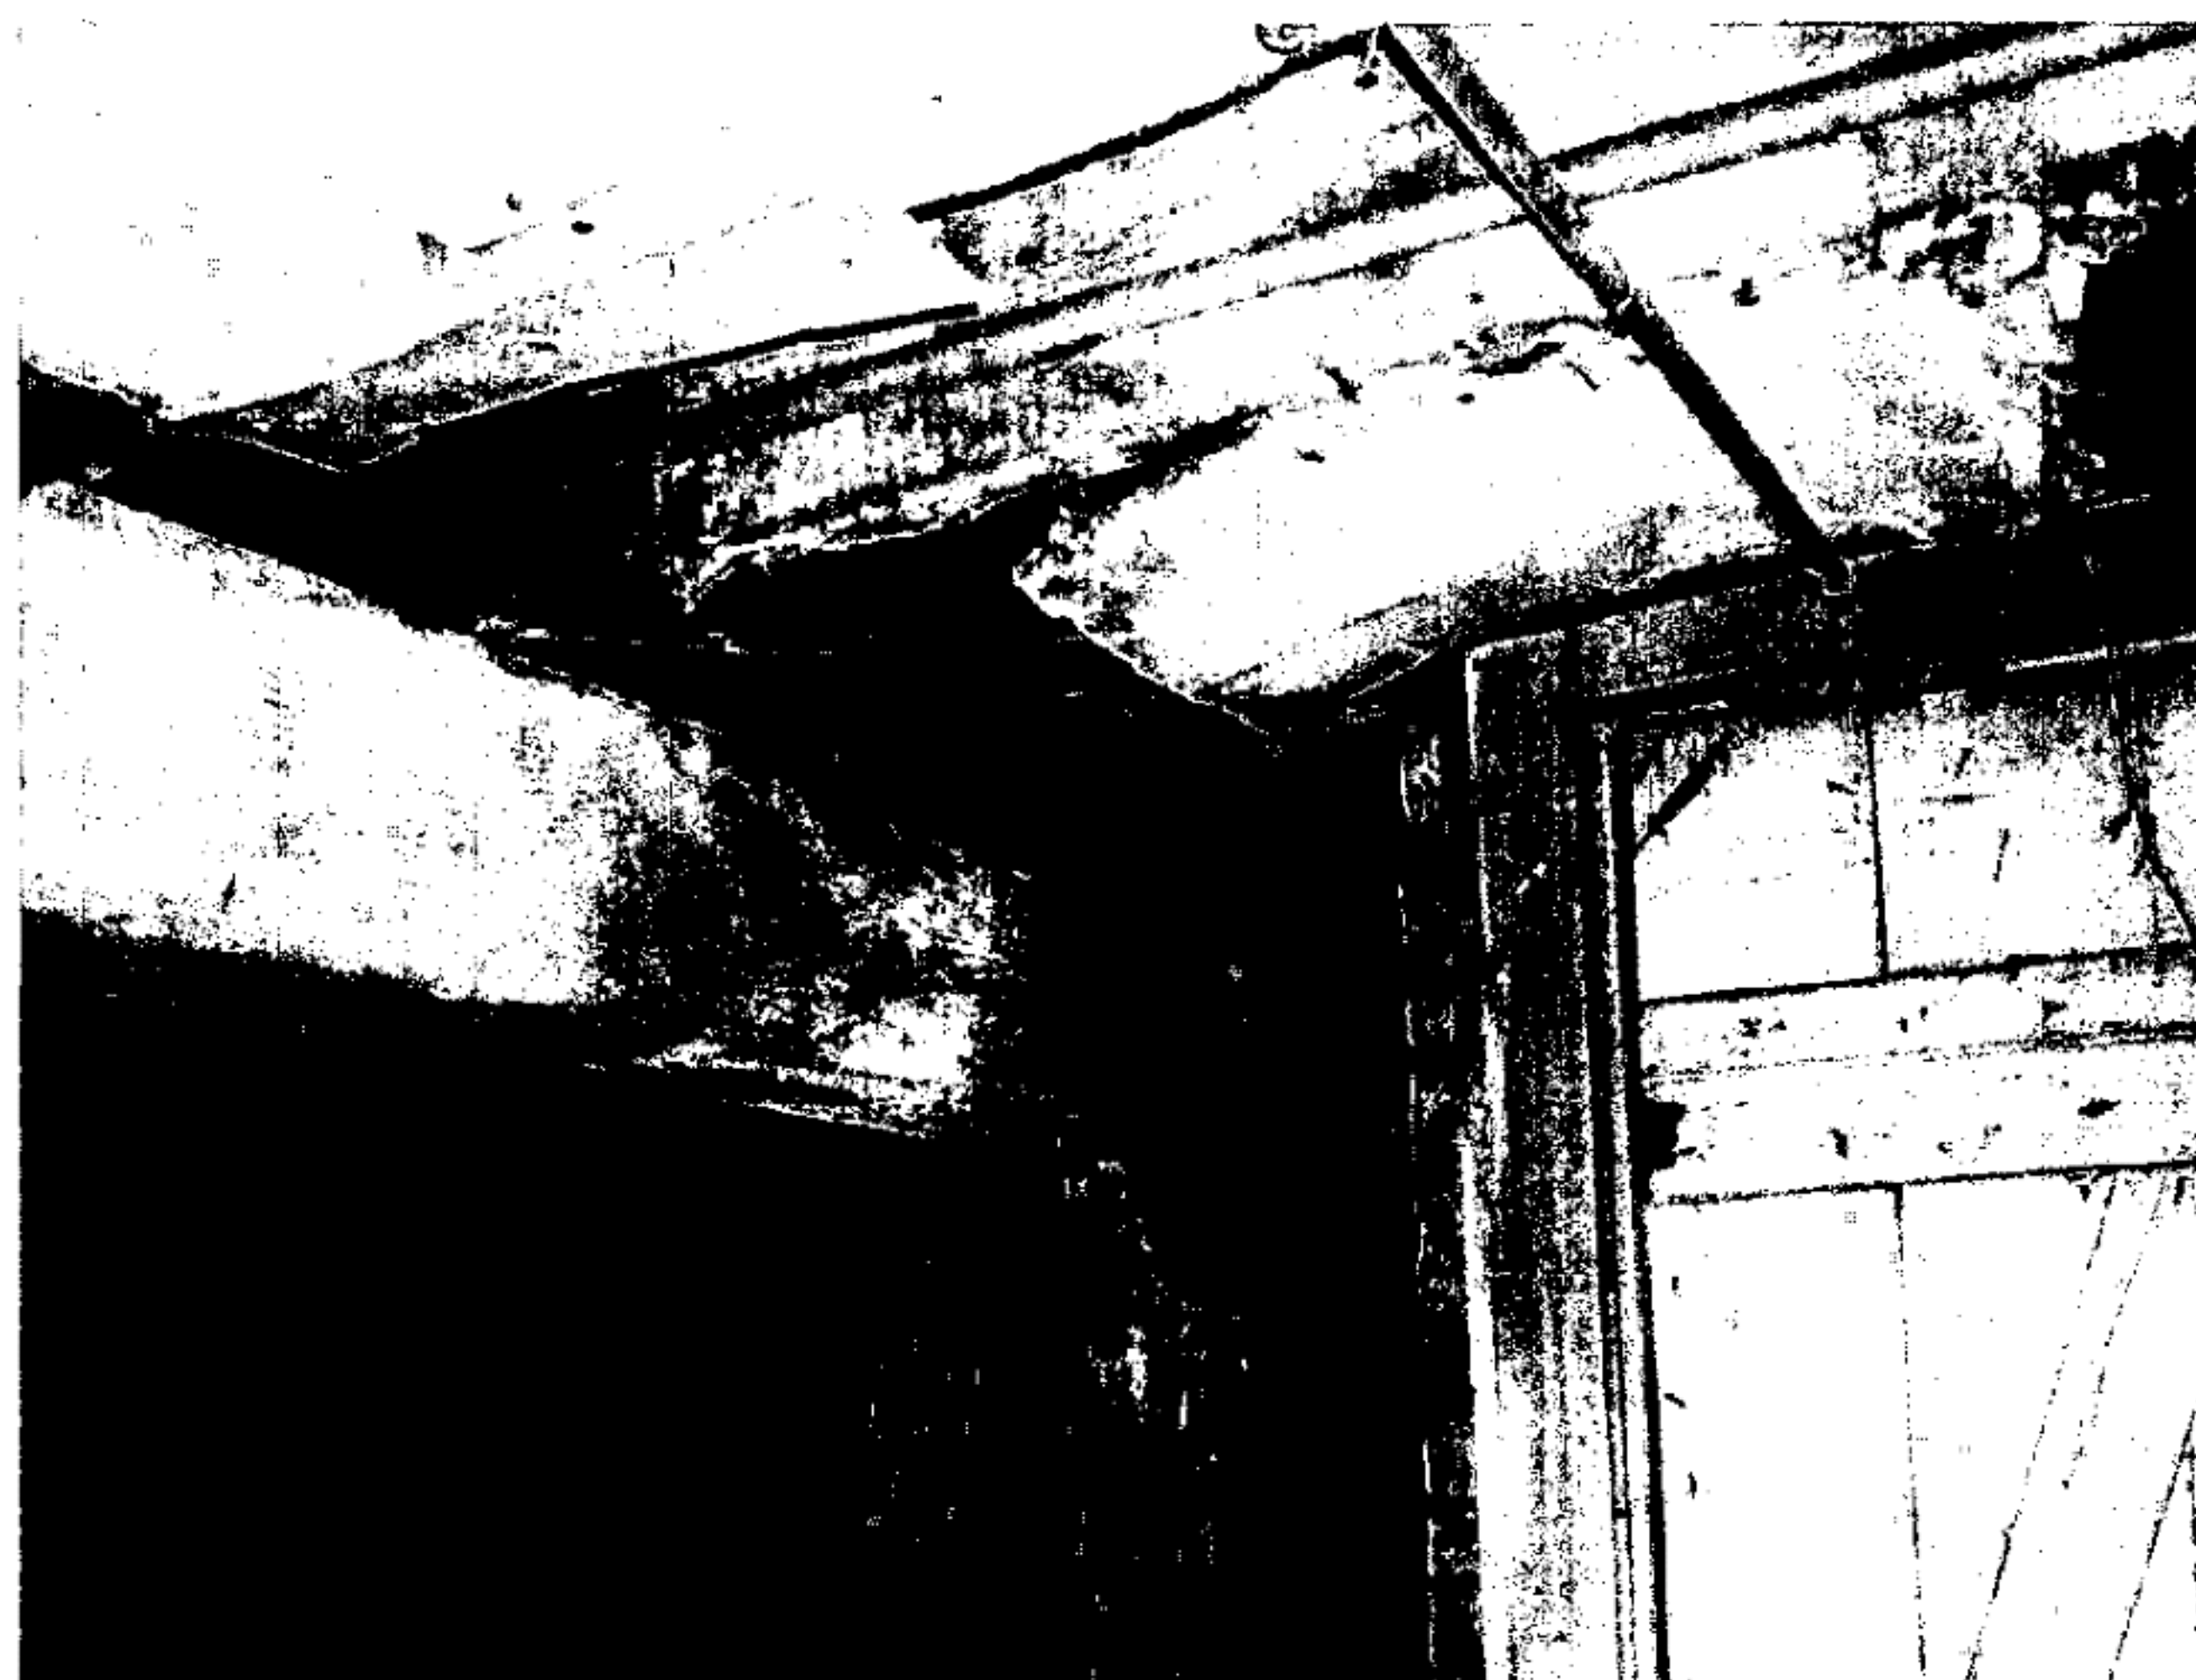
- The rear portion of the previously intact 2nd floor framing in 614 Atlantic Avenue had collapsed
- Continued foundation and girder settlement in 618 Atlantic Street (Refer to Photo No. 7)
- Continued 2nd floor framing damage in 616 Atlantic Avenue (Refer to Photo No. 11)
- Continued timber flooring and floor joist water and rot damage

**Photo No. 07 – Further Timber Column and Girder Support Settlement of
618 Atlantic Avenue (Condition on November 01, 2005)**
